SERVICE BULLETIN SS-MAR0234	model number 4220	bulletin number M-4220-1
	for serial numbers ALL	
	subject DRIVER IC REPLACEMENT	
	engineering approval

model number 4220	bulletin number M-4220-2
for serial numbers ALL	
subject SERVICE MANUAL CORRECTION	
engineering approval D. Almeida 7-14-76	date 5/20/76

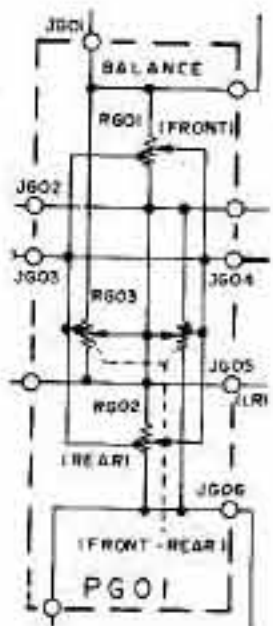
INCORRECT

This Service Bulletin corrects an schematic error on page 12 of the Marantz Model 4220 Service Manual.
